VOYAGER ESTATE

CASE STUDY

VOYAGER ESTATE'S
REHABILITATION OF RIPARIAN ZONES
THROUGHOUT THE PROPERTY.

Revegetation of riparian zones within the Boodjidup catchment region with native plants to create habitat that will increase biodiversity of flora and fauna, prevent erosion of sensitive areas, and improve overall water quality entering and exiting the property.

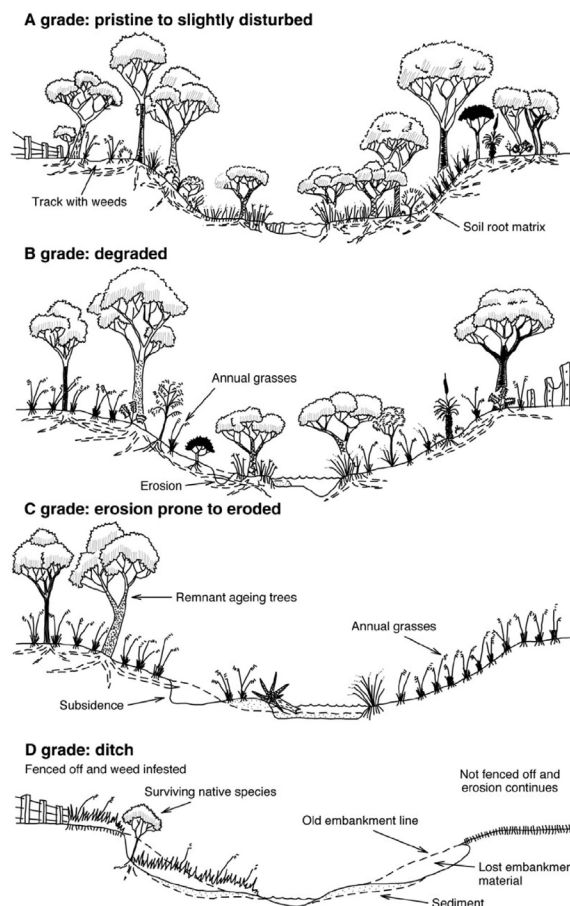
Figure 1. Four grades, A, B, C, and D of river foreshore condition based on the Pen-Scott method of riparian assessment of waterway health in the south-west of Western Australia. Each grade was divided into 3 subsets (1, 2, and 3), for full explanation refer to the Boodjidup Brook Action Plan (CCCG 2009).

When considering biodiversity area, it is not only important to note the overall area but also the increase in quality of that area (Figure 1). Revegetation at Weightmans dam has created an ecological wetland system that has seen increased birds, arthropods, and amphibian activity.

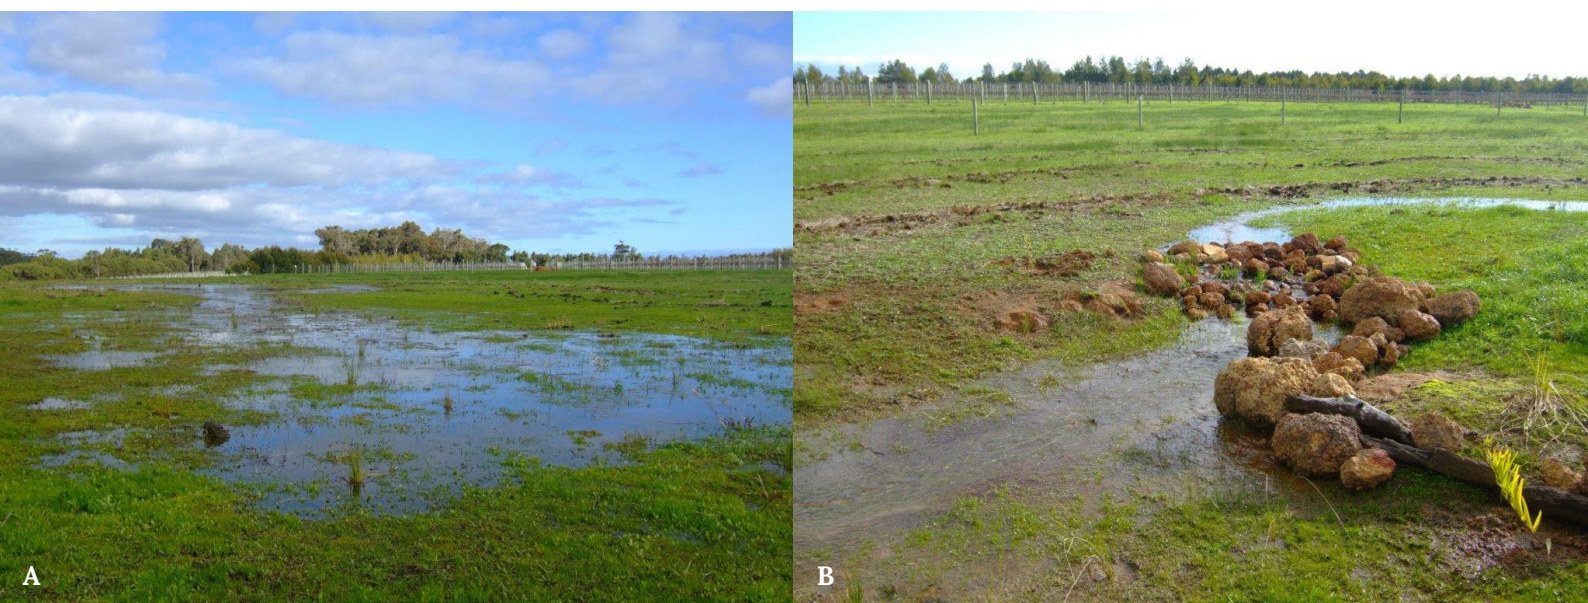
Figure 3. Rock pitching was used to decrease and direct the flow of winter catchment in watercourse B (refer to Figure 2); image A was taken prior to the rock pitches being installed, while image B highlights the extent to which the pitching has controlled water flow, preventing flooding of the paddock.

In waterways classed as C and D fencing was installed to exclude livestock, weeds removed, and riparian zones were replanted. Importantly erosion control was further managed by strategically placing rocks within the water channel (Figure 3), creating rock pitches, to slow water flow through these areas allowing vegetation to establish itself, stabilising banks.

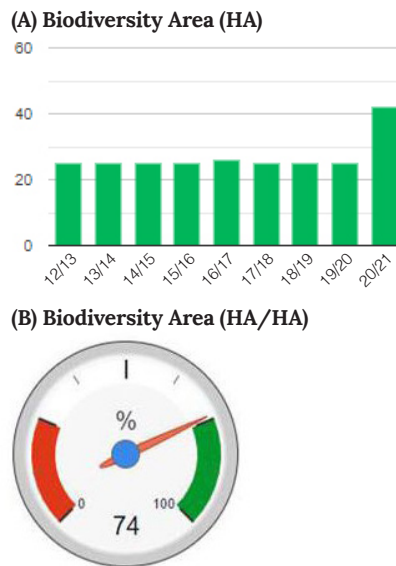
Figure 4. Voyager Estate's Sustainable Winegrowing biodiversity area metrics (A) and business indicator metrics (B). From 2012/13 to 2020/21 reporting periods. From 2012 to 2020 the area is approximately 25 Ha; in 2020-21 reporting period it increased to 42 Ha. Sustainable Winegrowing Business indicator metrics show Voyager Estate is in the top 26% of all members in relation to the area of their property under biodiverse land, which includes riparian zones, watercourse and remnant bush. Estate has been submitting the total biodiversity area metrics, defined as remnant bush/vegetation and revegetated areas, to Sustainable Winegrowing (Figure 4). The significant jump in biodiversity area recorded from 2019-20 (25 Ha) reporting period to 2020-21 (42 Ha) is due to a change in how the area was calculated. Prior to 2020 the area had been estimated internally and based on maps that were not current.

Given the extensive revegetation programs undertaken between 2009 and 2017 Voyager Estate had the biodiversity area assessed externally resulting in a 68% increase compared to prior best estimates. This is a remarkable outcome, positioning them in the top 26% of Sustainable Winegrowing members, and while they may have underestimated prior records there is no doubt that the area of biodiversity on Voyager Estate has increased. Any significant rehabilitation works should be reviewed every five to ten years to understand the return on investment both ecologically and financially.

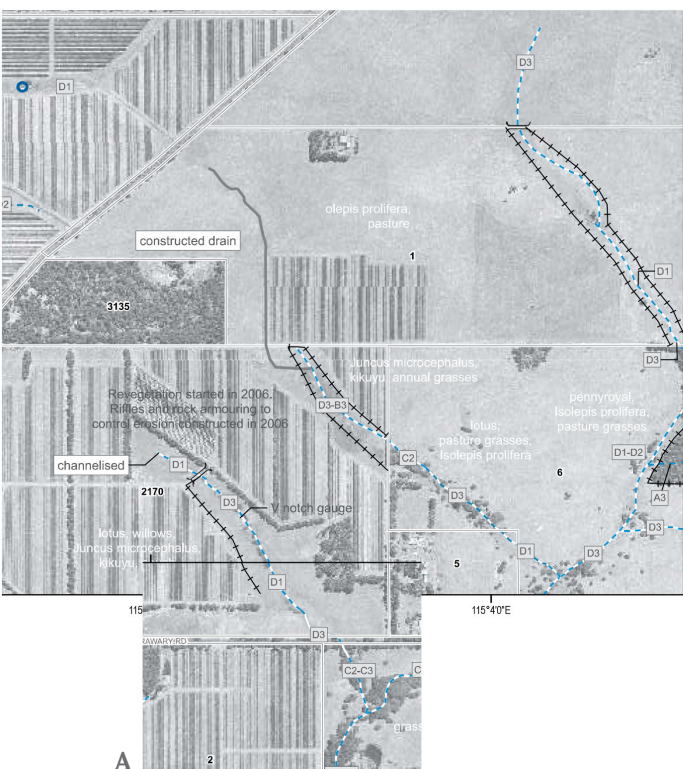
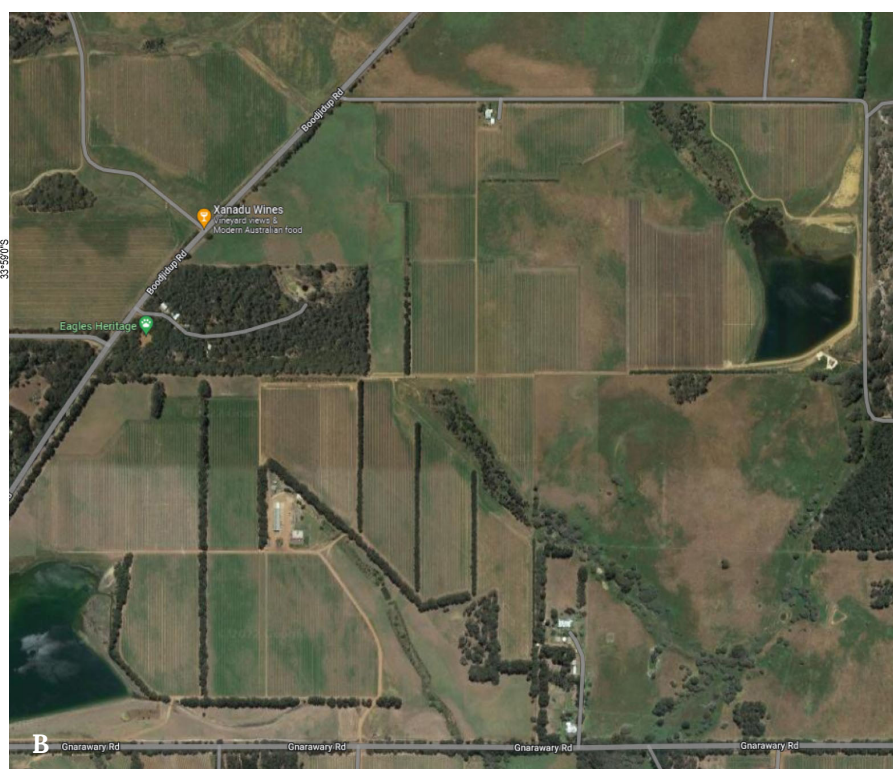
Figure 5. Comparison of revegetation over time. Image A is prior to 2009 and sourced from Boodjidup Brook Action Plan (CCCG 2009). Weightman Dam had not been constructed yet and is a bare paddock with the watercourse graded as class D3, heavily eroded. Image B is sourced from Google Maps, circa 2013–2017, the revegetation program at Weightman Dam (Figure 2, location C) had not commenced with riparian revegetation to Ullinger’s Creek line, (Figure 2, location A) newly established.

The site was originally classed as D1 to D3 (eroded ditches), with no native vegetation present, this can be seen from an old aerial image in Figure 5A, before the dam was constructed and then in Figure 5B following construction but prior to significant plantings becoming established. Since completing planting programs around Weightmans dam the area has increased in quality (Figure 6) and a formal assessment could potentially have it classed as high as B grade foreshore, which is defined as native species are dominant however weeds remain present and form a significant component of the understorey (CCCG 2009).

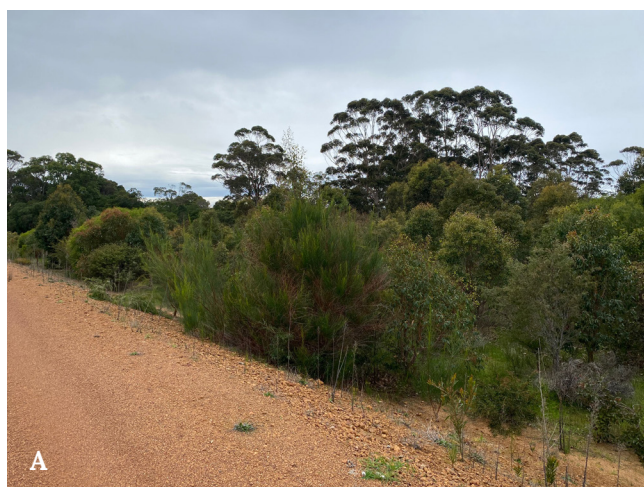
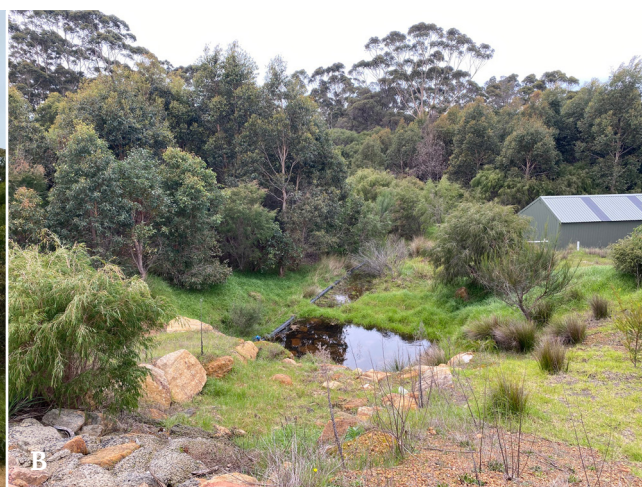
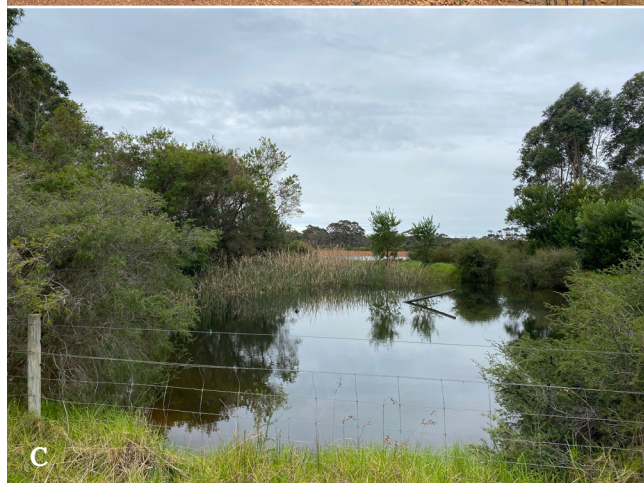
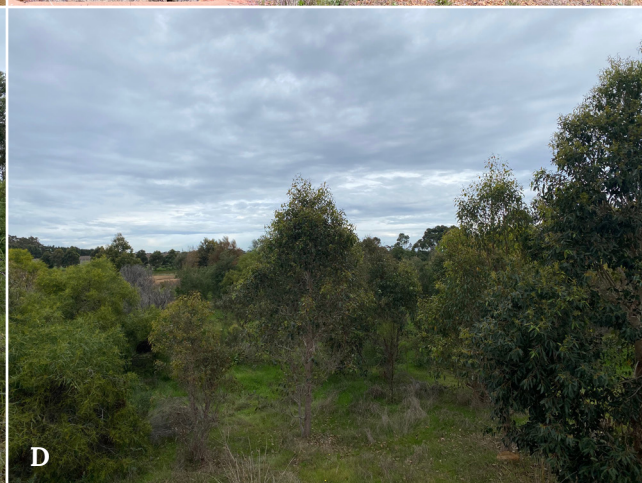
Figure 6. Weightmans dam revegetation; A and B southwest spillway area of dam that was previously bare land, now has multiple storeys of vegetation; C and D are to the northwest of the dam with wetland areas well established and surrounded by larger trees supporting a biodiverse multi-layered ecological system.

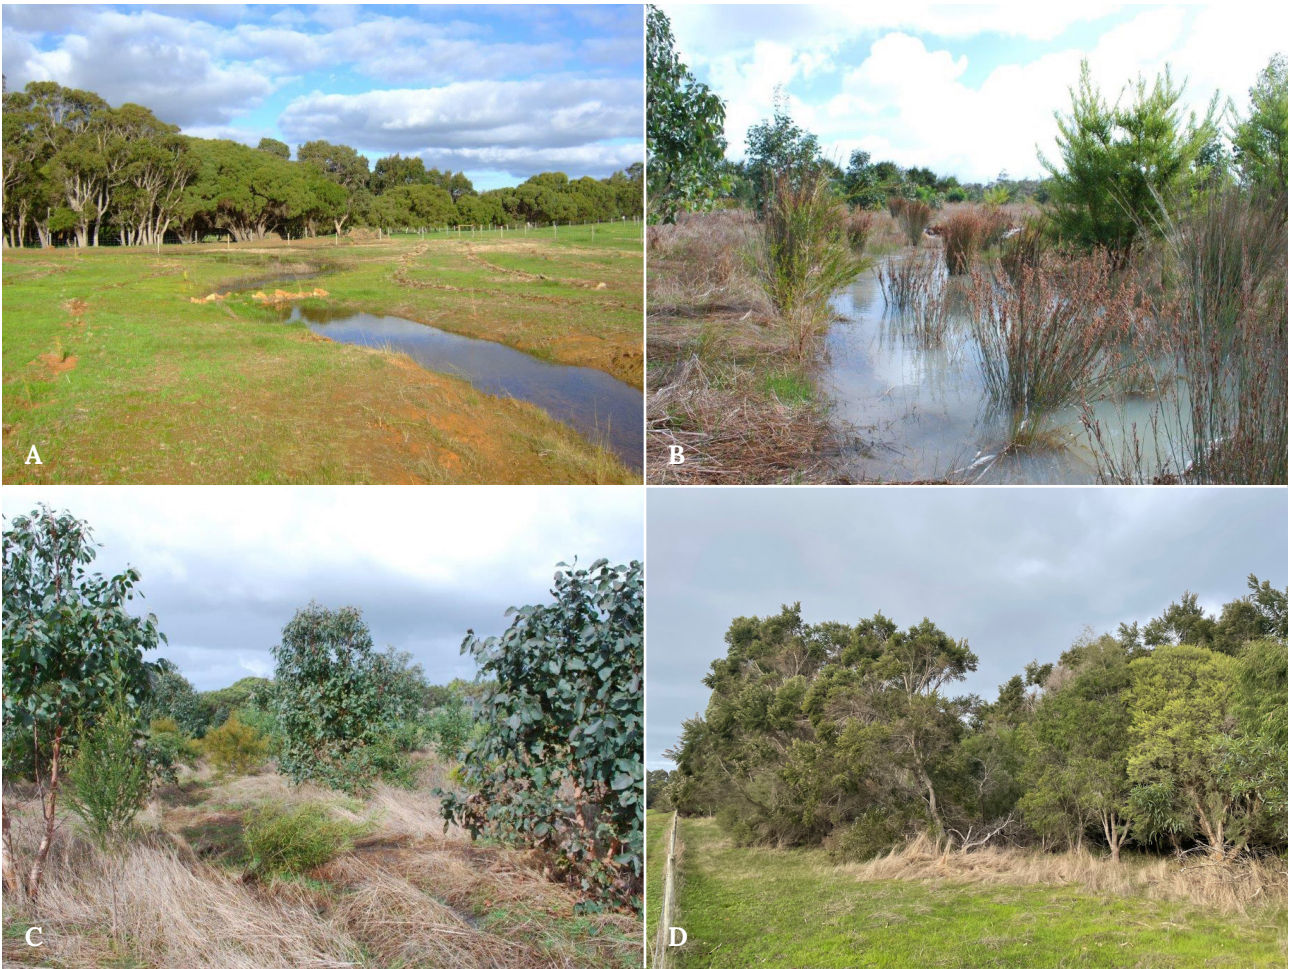
Figure 7. Riparian revegetation of watercourse B (refer to Figure 2), graded class D3, commenced over two seasons in 2007 and 2008 with 3000 trees planted each time between June and October. Image A was taken prior to commencement of plantings, showing rock pitches that had been installed the previous season; image B is 12 months later showing good growth of young trees and rushes; image C taken four years after planting in 2011; and image D, taken in 2022, shows strong establishment of trees with understorey, an improvement in foreshore condition from D to possibly B class.

Erosion control of waterways in conjunction with riparian revegetation, as seen in Figure 7, which shows rock pitches installed prior to planting (Figure 7A) on a watercourse classed as D3, and then one year after planting (Figure 7B), four years after planting (Figure 7C) and current growth in 2022 (Figure 7D), with fencing protecting the rehabilitated area, has resulted in a significant increase in biodiversity area with natural habitats for birds, arthropods and aquatic life, especially frogs. The rehabilitated native areas adjacent to vineyards provide

overwintering habitats for beneficial arthropods, a critical component when implementing integrated pest management. A reassessment of the foreshore condition of this area would see it graded significantly higher than D3, with well-established native second storey vegetation and a mix of predominantly native species in the understorey.

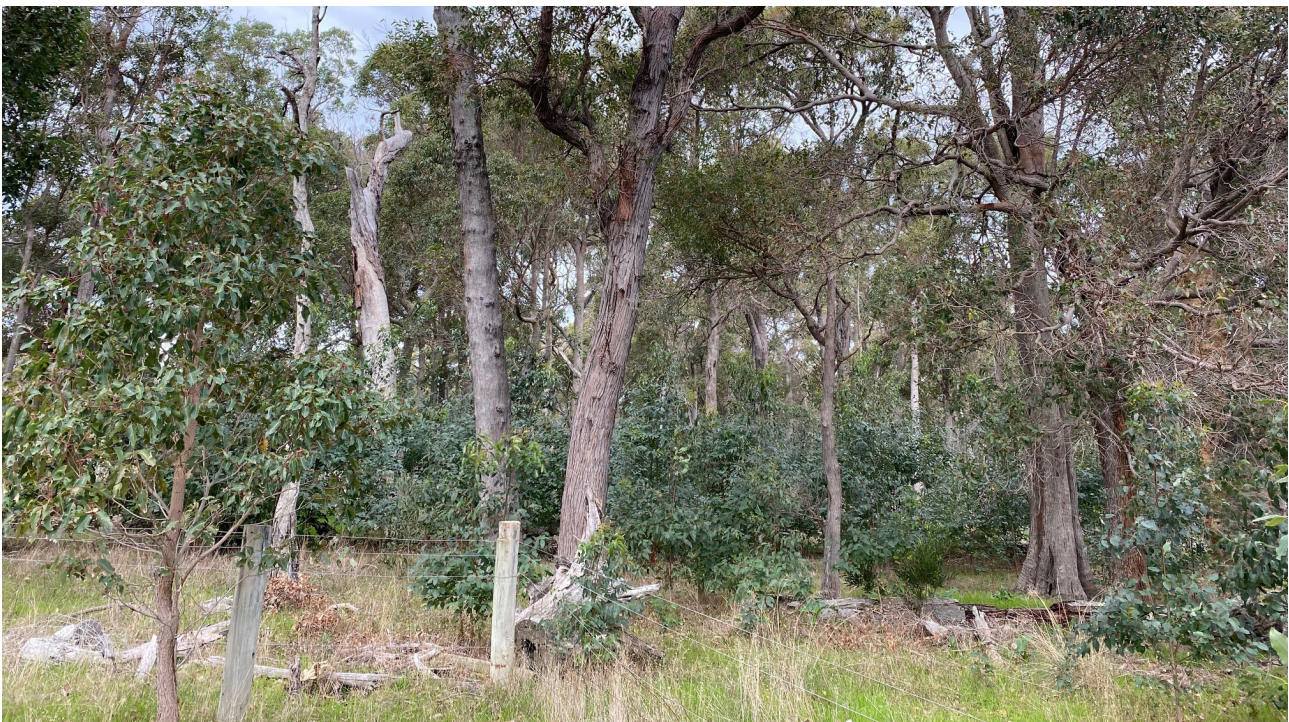
Figure 8. A-grade remnant bush protected from livestock grazing showing the natural re-establishment of understorey with self-seeded saplings and other native species.

Exclusion of stock through the use of fencing around an area of A-grade remnant bush, followed up by weed removal, predominantly arum lily, has seen the natural re-establishment of

the understorey with young saplings and a range of other native species (Figure 8). Prior to fencing there was no understorey. This has proven to be one of the most cost effective and low maintenance projects at Voyager Estate.

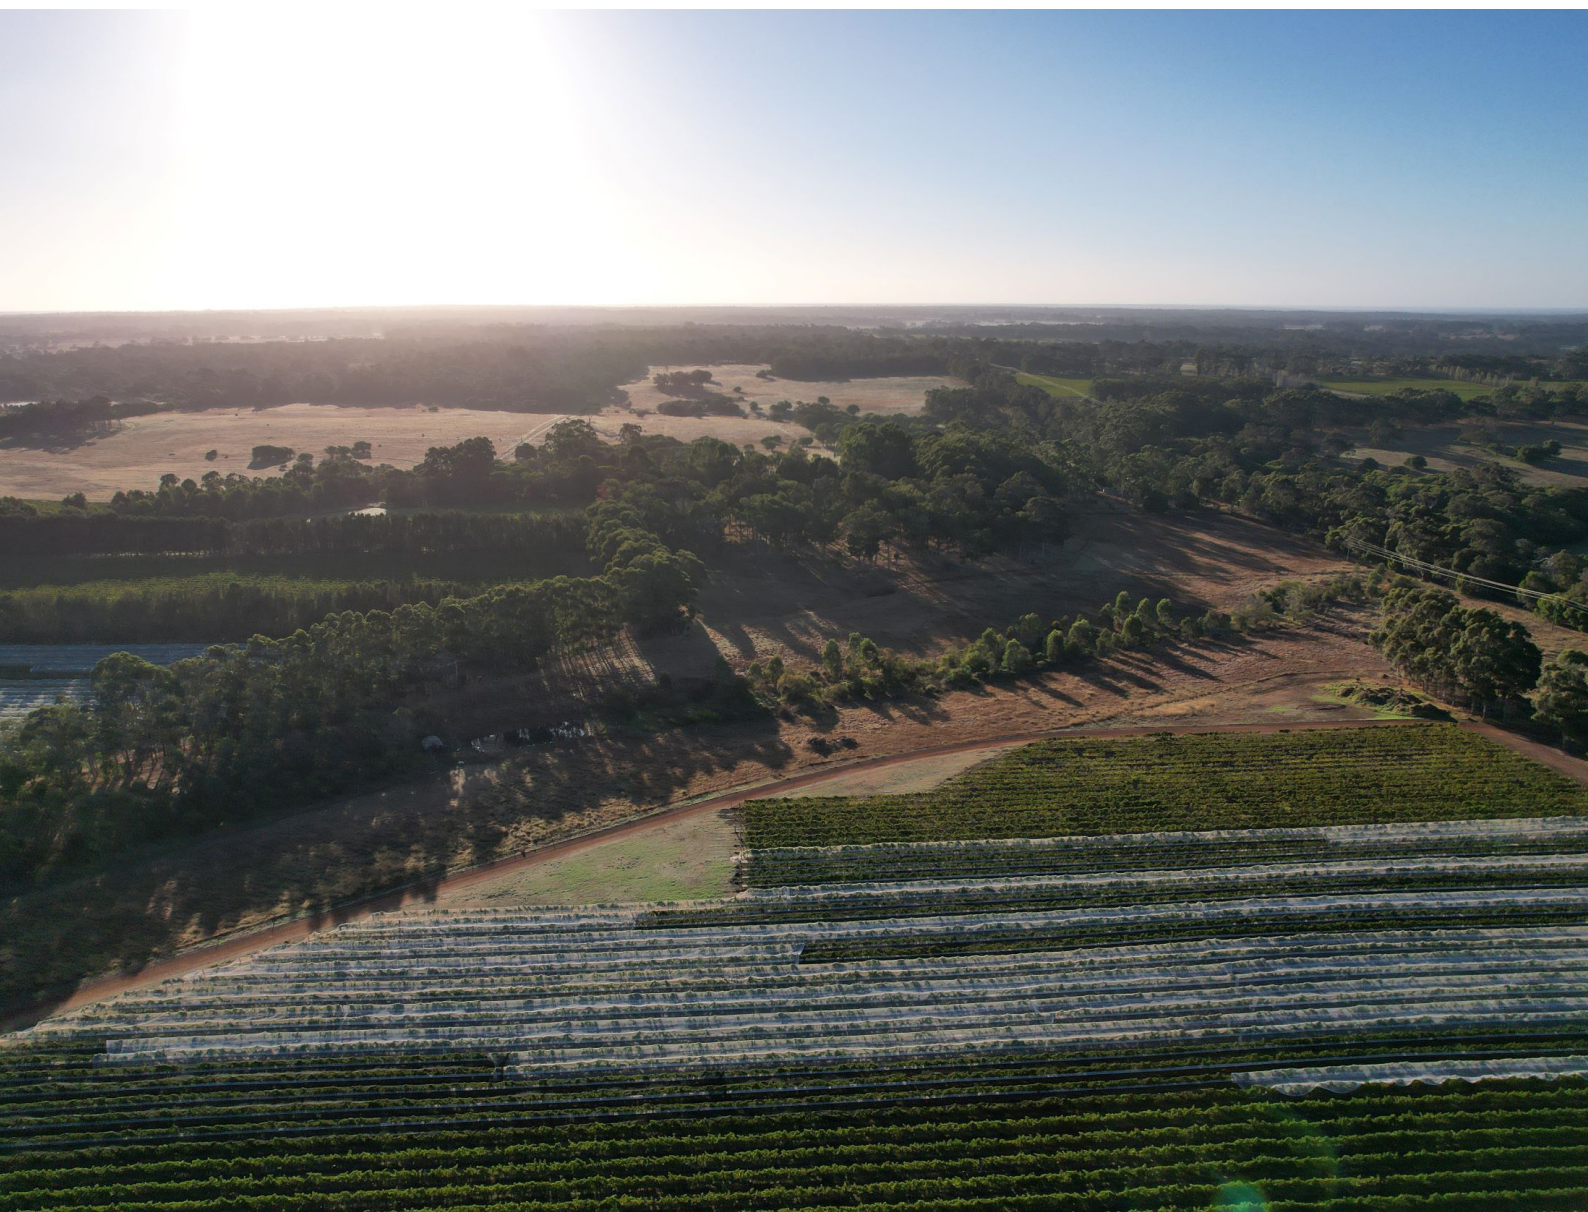
Figure 9. Looking east across Ullinger's winter creek revegetation adjacent to vineyards, over rehabilitated remnant bush, through to Weightmans dam in the top left corner.

The sum of all the parts has created a complex patchwork of native vegetation corridors across Voyager Estate with significant increases in the biodiversity of those areas, stabilising watercourses and creating natural habitats for a diverse range of beneficial arthropods, amphibians, birds, and animals (Figure 9).
